**State of Louisiana  
Department of Natural Resources  
Coastal Restoration Division**

**2006/2007 Annual Inspection  
Report**

**Barataria Bay Waterway East  
Bank Protection  
(BA-26)**

State Project Number BA-26  
Priority Project List 6

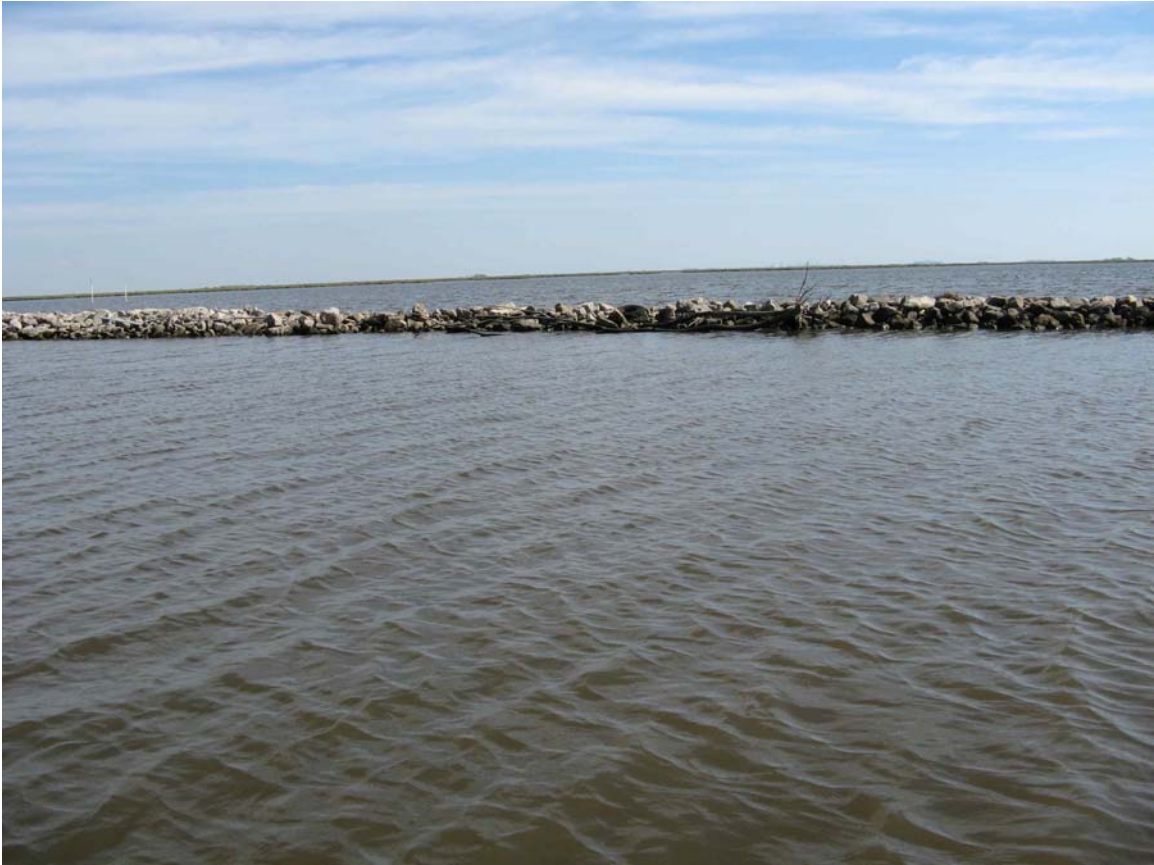
There are no noticeable damages to the rock structure since the previous inspection (Photos #1 & #2). A small gap in the rock structure was seen at approximate coordinates N29.61380°, W 090.07905°. This gap is probably the result of vandalism and should be monitored (Photo #3).

**Photo #1 – Shoreline Protection.** Rock structure, note occasional debris.

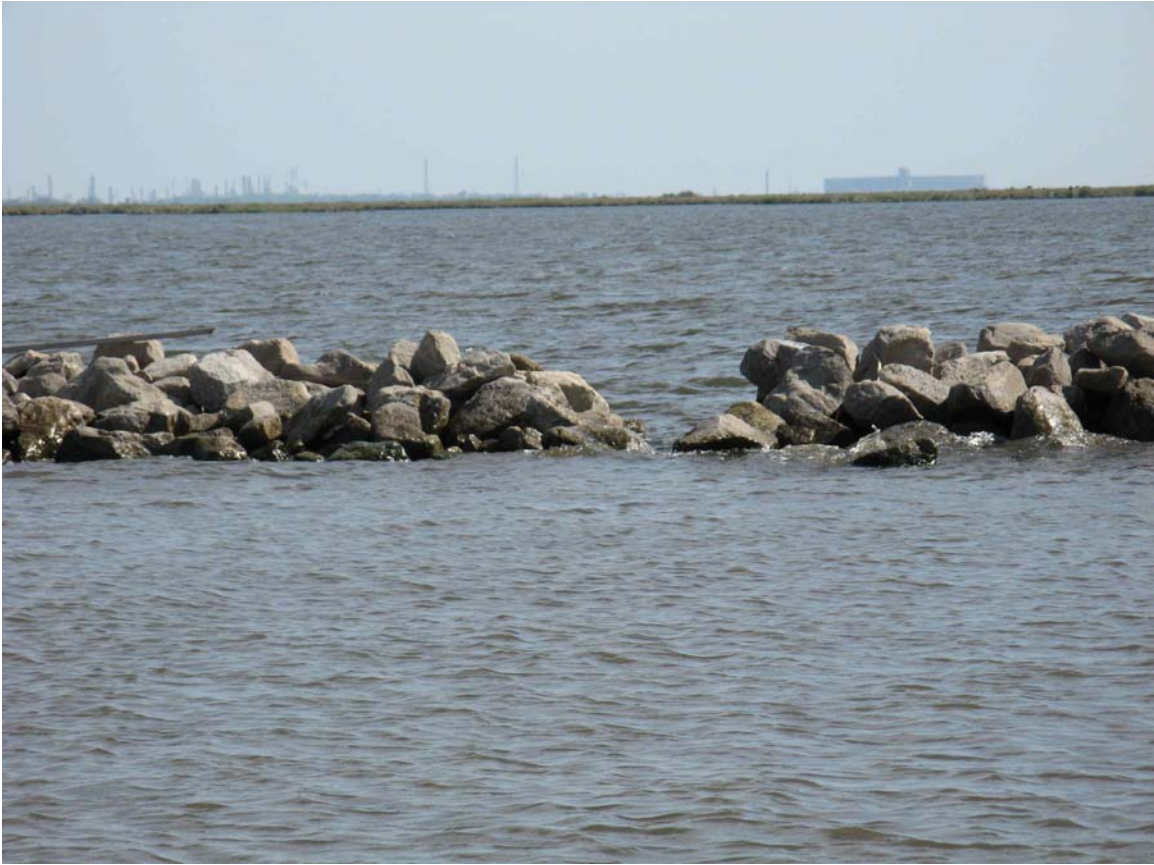
**Photo No. 3 – Small gap in Shoreline Protection.**

Item	Condition	Physical Damage	Corrosion	Photo #	Observations and Remarks
Foreshore Rock Dike	Good	small gap	None	1,2,3	
					small gap at approx. coordinates N29.61380, W090.07905
Settlement Plates	Good	None	None		
Signage /Supports	Good	None	None
